Quarterly Report
Covering July 1, 2006 to September 30, 2006
Submitted October 3, 2006

Fish Passage in Montana Culverts Phase II – Passage Goals

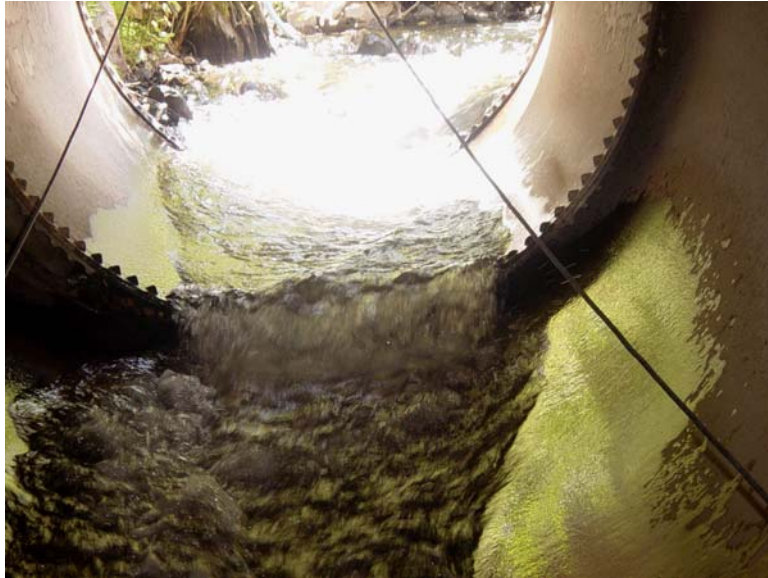
We are finishing up some cross section surveys at the bridge and in the control reach. Velocity-flow rate correlations have been made at all the culverts except culvert 5, and will soon be completed for the bridge and control reaches. Culvert 5 has yet to have a tagged fish pass through it, so it will have no successful passes to be entered into the statistical model. If there are no successful passes, a relationship between velocity and flow rate is unnecessary. This culvert (5) suffers from nearly all of the characteristics of a barrier (perched, overly sloped, high velocity, shallow depth), plus it is made of two different diameter pipes (Figure 1) so it really has a barrier within a barrier!

Figure 1. The change in pipe diameter within culvert 5 (standing in the pipe looking upstream) at a low flow rate (approximately 4 cfs). When this picture was taken, the mean velocity in the pipe was visually estimated at 8 to 10 ft/sec, and the flow depth throughout the pie was approximately 3 inches at the invert.
